# Pressure ports/RVSM areas contamination findings

RAMP Train-the trainer workshop

An Agency of the European Union

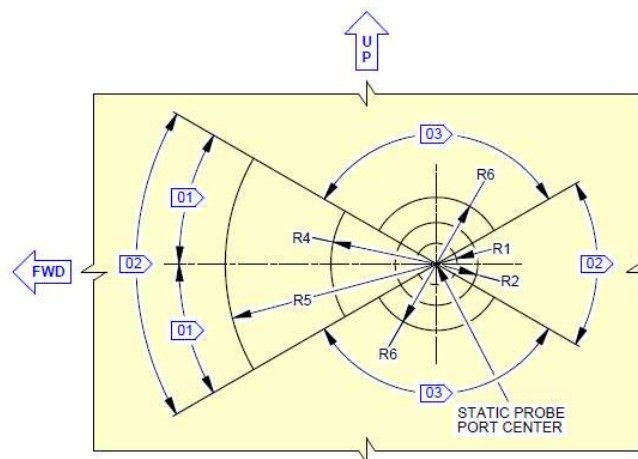
DIMENSION AND CONVERSIONS		
	mm	in
R1	100	3.94
R2	200	7.87
R4	500	19.69
R5	1 000	39.37
R6	325	12.8

**03** REFER TO FIGURE 6 FOR ALL STATIC PROBE PORTS.

If the damage is more than the requirements and limitations given in Paragraph 2.A.(3).(a)., repair the damage according to the aerodynamic requirements given in Diagram 001 and Diagram 002 and the requirements given below:

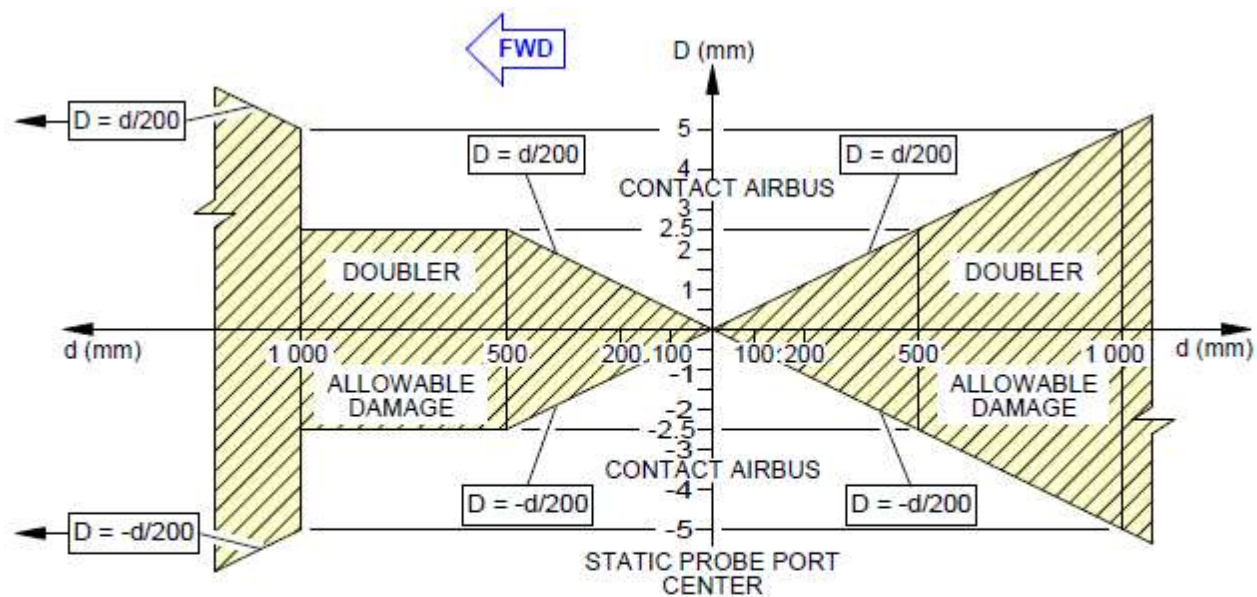
N\_SR\_530011\_1\_6AQM0000\_01\_01

NOTE:  
THESE AERODYNAMIC REQUIREMENTS ARE APPLICABLE FOR 02  
MARKED AREAS GIVEN IN FIGURE 4.

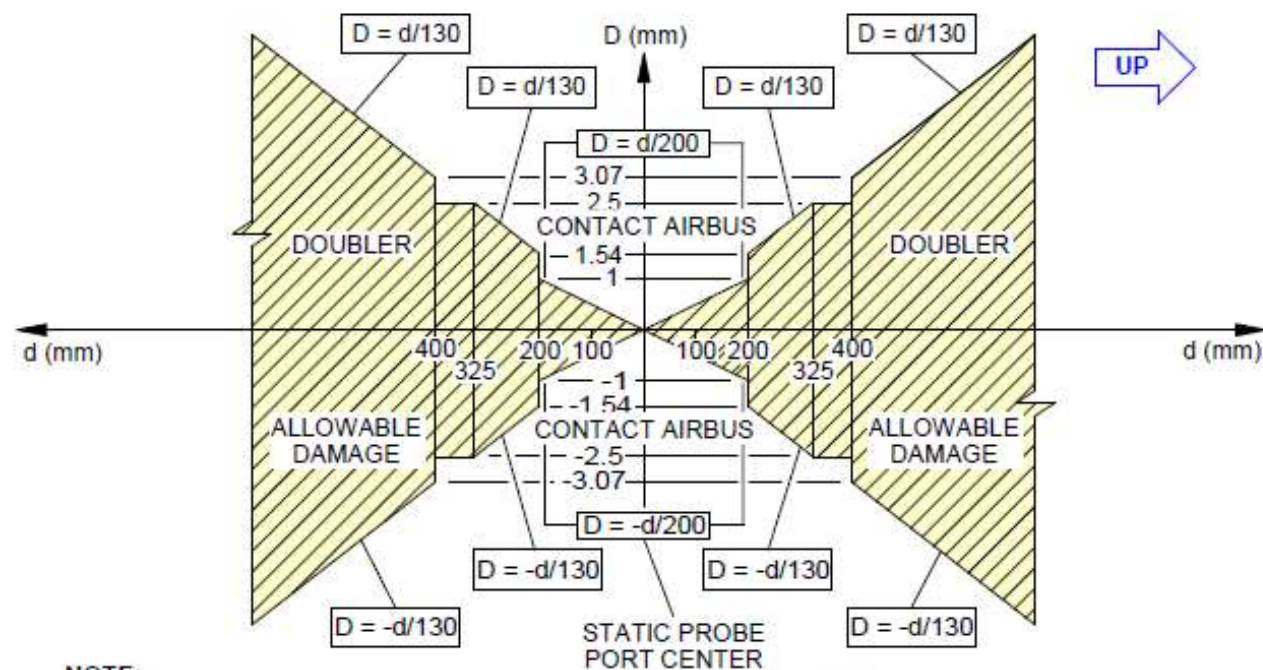
N\_SR\_530011\_1\_6ASM0000\_01\_01

NOTE:

THESE AERODYNAMIC REQUIREMENTS ARE APPLICABLE FOR 03

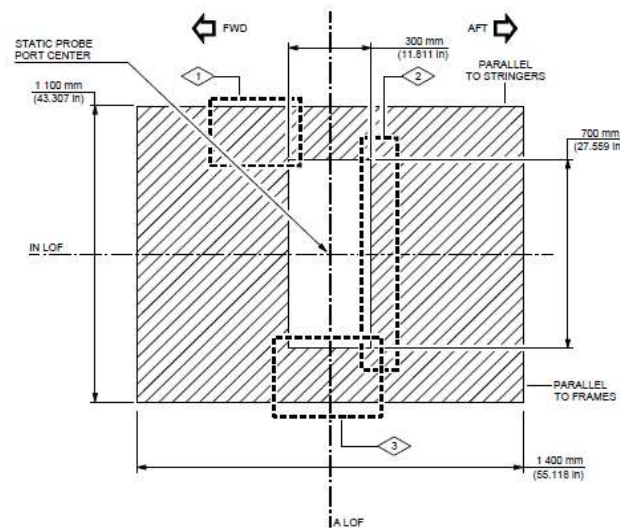
## NOTE:

1 NOT PERMITTED:  
NO EXTERNAL REPAIR DOUBLER CORNER PERMITTED IN AREA A.

2 NOT PERMITTED:  
NO EXTERNAL REPAIR DOUBLER TRAILING NOR LEADING EDGE PERMITTED IN AREA A.

3 PERMITTED:  
EXTERNAL REPAIR DOUBLER.
